Property ID # 2995 / 4312 York Street

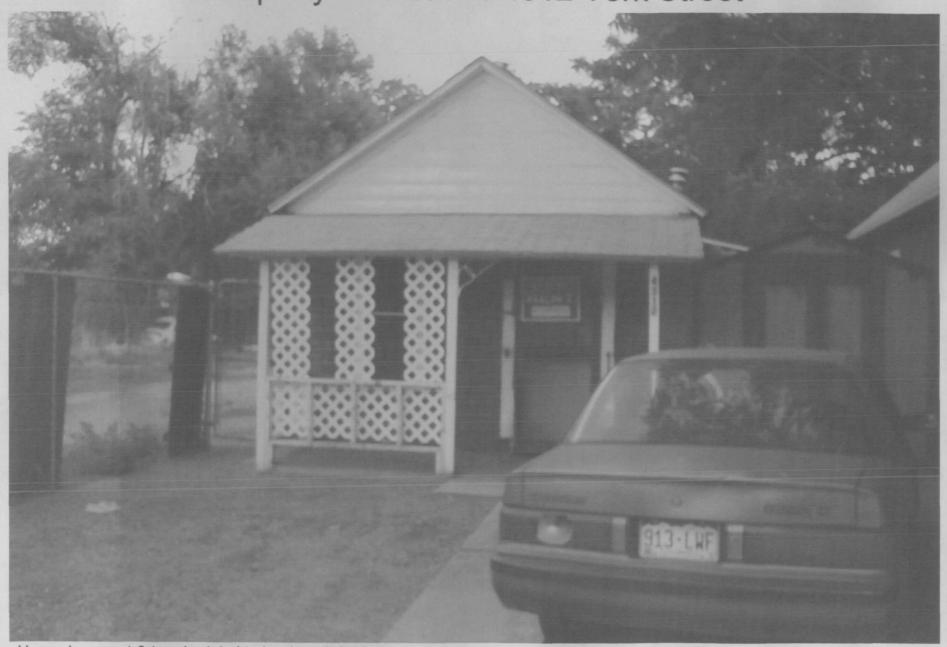
House is vacant & is scheduled to be demolished
